ELIMINATOR[®] overcomes tough environmental challenges

Waterproofing Warsaw's busiest expressway

Project	Grota Bridge
Client	General Directorate of Roads and Motorways
Contractor	B7
GCP Solutions	ELIMINATOR [®] Bridge Deck Waterproofing system

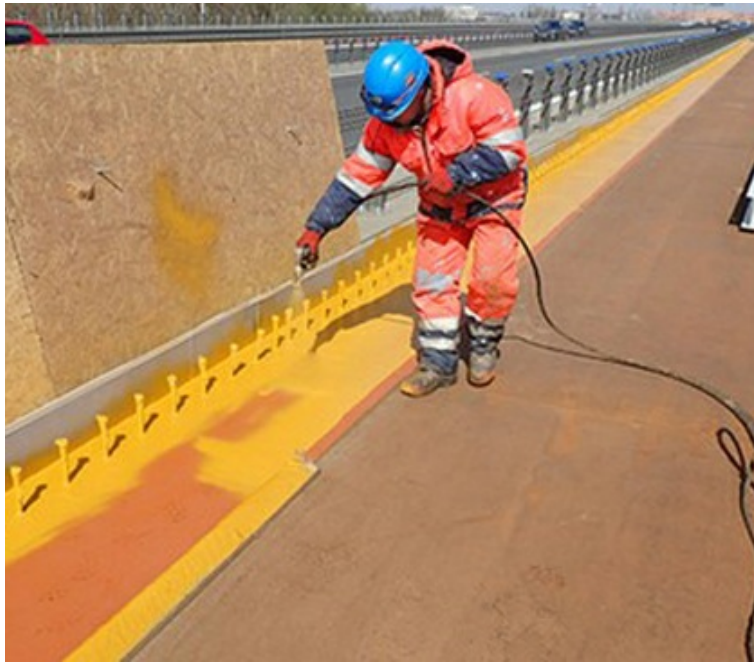
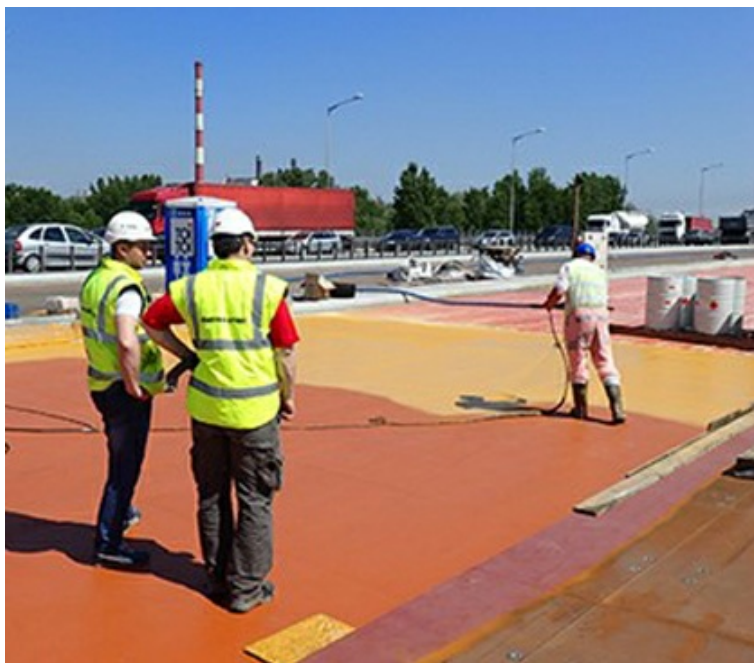
B7 and ZBM Inwestor Zastępczy Sp. Z o.o. selected the ELIMINATOR[®] system from Stirling Lloyd (now GCP Applied Technologies). DWD Service Sp. z o.o. prepared the deck by shot blasting using metallic grit, an independent assessment was completed to ensure the correct deck preparation to achieve a strong bond between the substrate and subsequent waterproofing .

The waterproofing system comprised of an initial anti-corrosive primer, ZED S94, which served to protect the newly exposed steel deck and enhance the bond between the deck and membrane. Once this dried, the ELIMINATOR[®] system was spray applied in two coats of contrasting colours to aid in quality control.

Tack Coat No. 2 was then applied to the membrane, an adhesive that helps to enhance and ensure a strong bond between the membrane and the surfacing. The adhesion between the deck, the ELIMINATOR[®] system and surfacing was crucial for extending the life of both the surfacing and the structure.
